# Navajo Abandoned Uranium Mine

## Site Screen Report

**Mine Name: Zhealy Tso, North Prospect**  
**Mine ID: 300**

**August 2011**

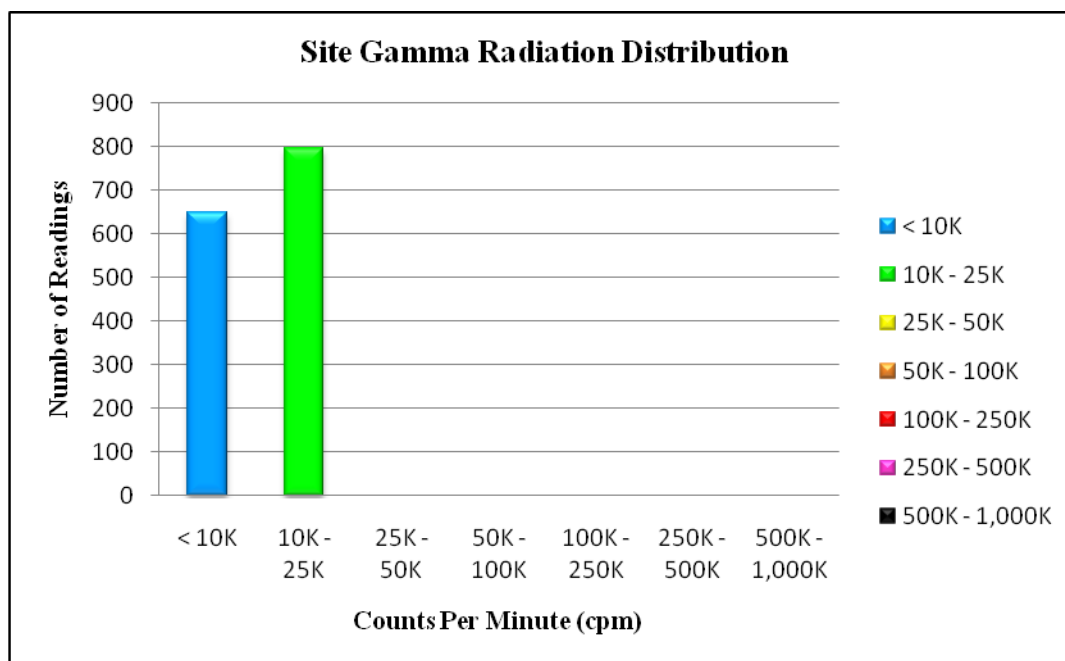
### Distribution Chart and Statistics:

A total of 1,444 gamma radiation measurements were collected from the mine site, ranging from 7,135 cpm to 19,029 cpm. The measurements are represented in Figures 1 and 2.

Site Gamma Radiation Statistics	
Number of Readings	1,444
Minimum (cpm)	7,135
Maximum (cpm)	19,029
Mean (cpm)	10,346
Median (cpm)	10,164
Standard Deviation	1,346

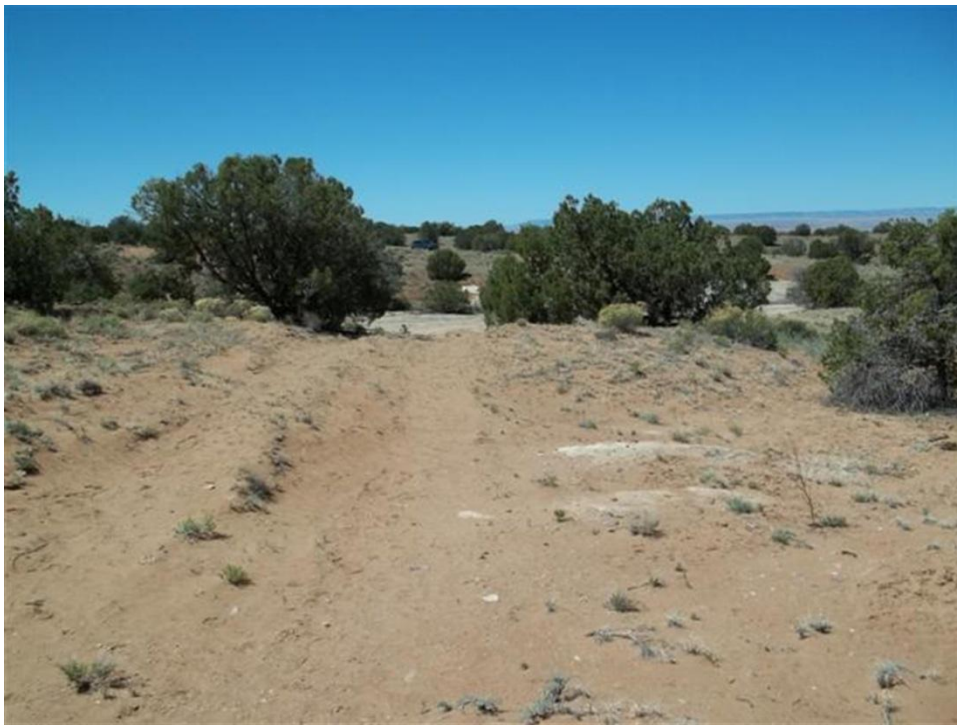
**Photo 2:** Mine Site #300; Road leading into site

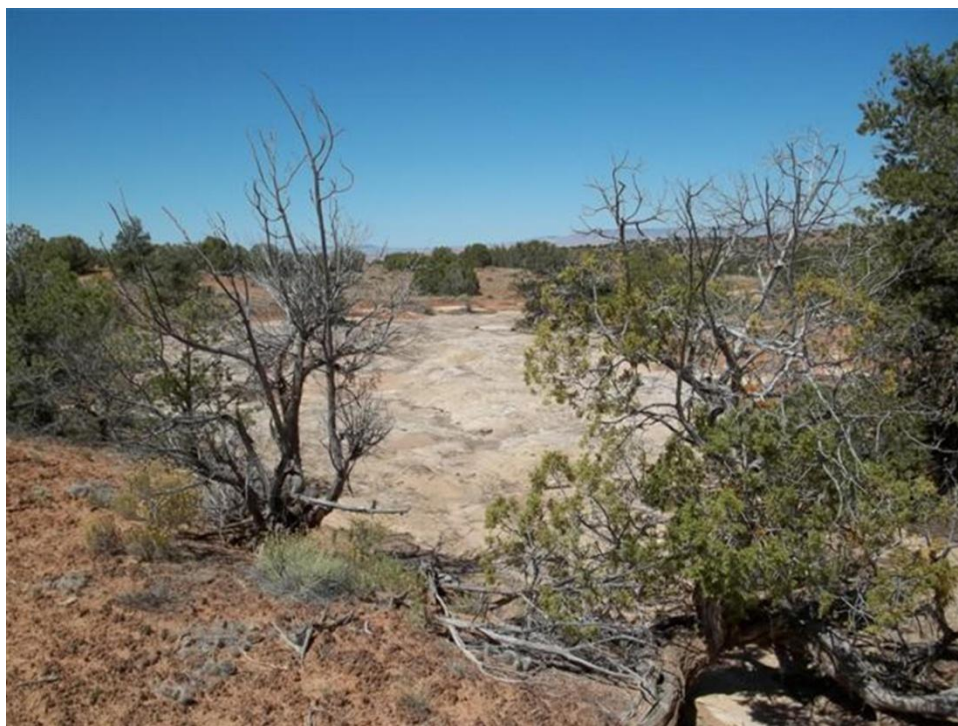
**Photo 3:** Mine Site #300; hard pan drainage through center of site

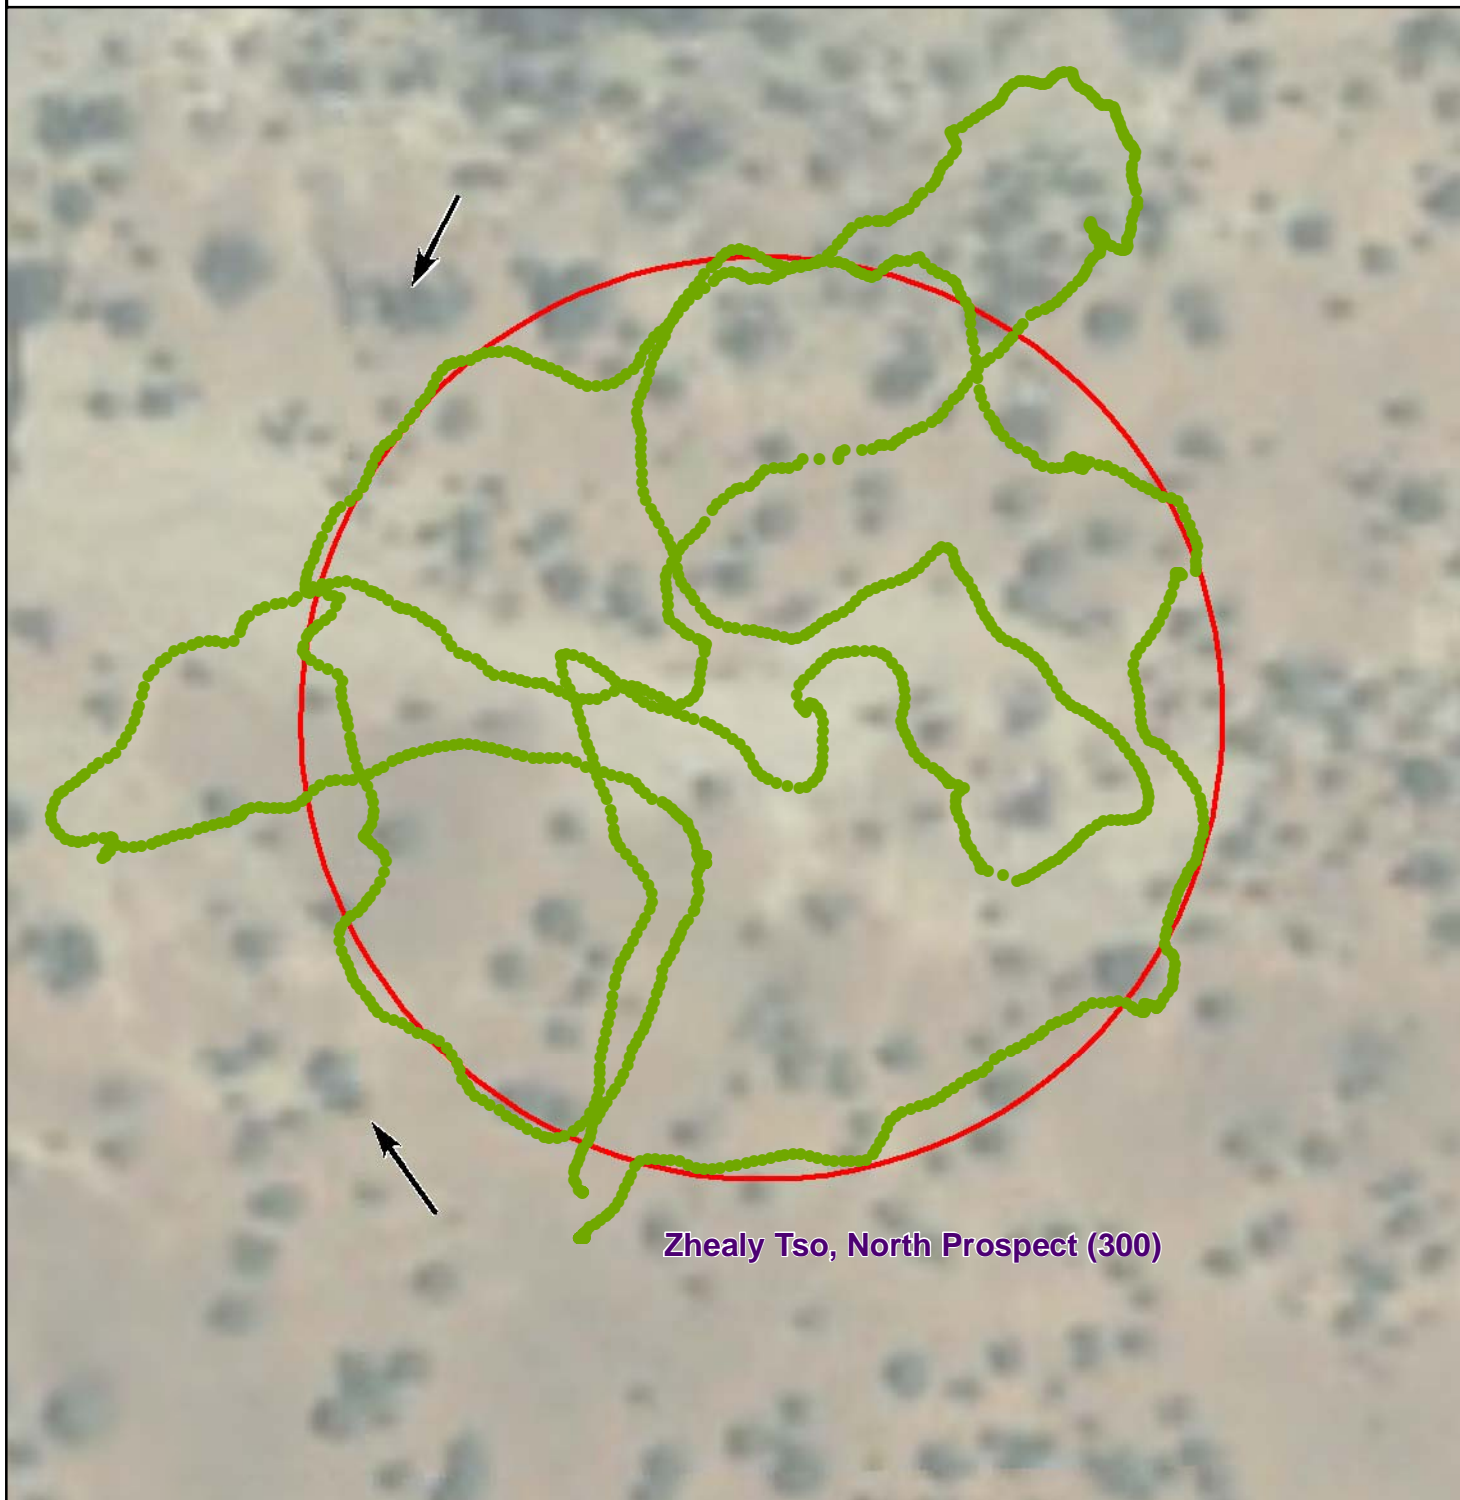
**Figure 1 - Gamma Radiation Measurements, Above Two Times Background  
Zhealy Tso, North Prospect (300)  
Chinle Chapter, Navajo Nation**

**Highest gamma radiation measurement:** 19,029 counts per minute (cpm)

**Background Average:** 9,760 cpm      **Two Times Background:** 19,520 cpm
